**Reserve Study for**

**Avalon Woods II Owners Association, Inc.**  
**Harrisonburg, VA**

**December 14, 2023**

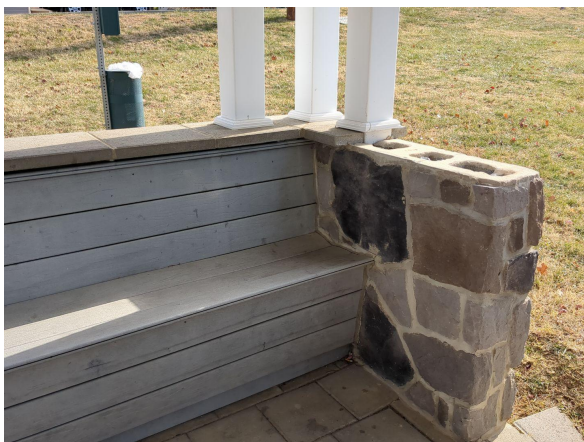
- The gazebo is showing signs of aging such as worn paint, damaged mortar joints, damaged and missing pavers, nail pops in the benches, and damaged metal roofing. Global Solution Partners recommends refurbishing the gazebo. Gazebo refurbishment has been included in this Reserve Study.

Damage at gazebo

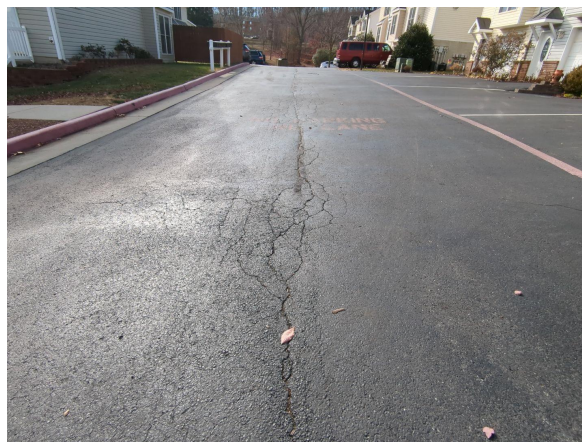
- The asphalt surfaces were observed to be in fair condition. Evidence of previous repairs were observed, the surface is worn, and cracking was noted throughout. Additionally, the asphalt curbing at the curve in Camelot Lane is damaged. Global Solution Partners recommends a mill and overlay of the asphalt surfaces. Asphalt surfaces should be resealed on a five-year schedule to provide protection from oxidation due to exposure to the sun and elements, minimize surface cracking, and enhance the aesthetics of the community. Mill and overlay, as well as patching and sealing of the paved areas has been included in this Reserve Study.

Worn asphalt parking

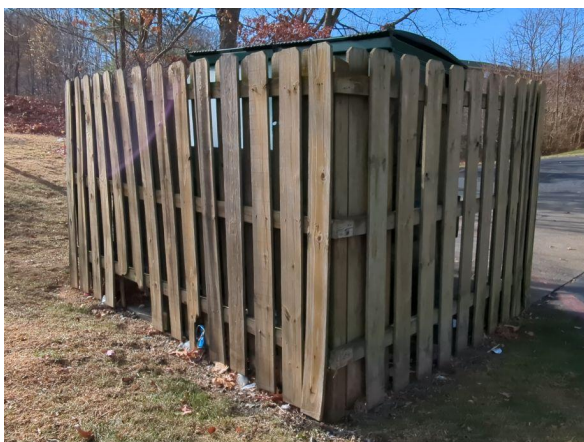
- All three of the dumpster areas have sections of damaged fencing. Global Solution Partners recommends replacing the damaged fencing. Wood fencing replacement has been included in this Reserve Study.

Damaged fencing

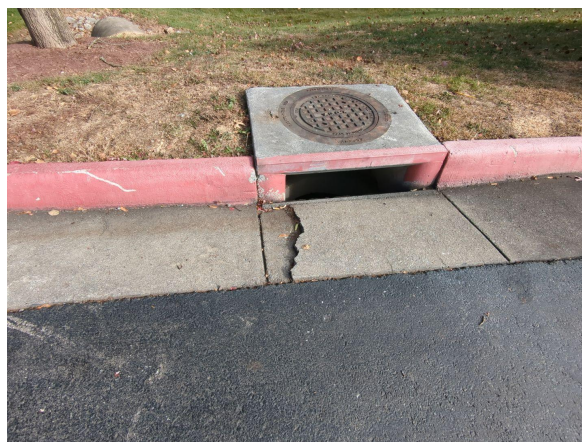
- There is a damaged section of concrete curb guttering at the parking lot stormwater drain closest to the first dumpster. Global Solution Partners recommends repairing the concrete guttering using operational funds as part of routine site maintenance.

Damaged concrete curb guttering

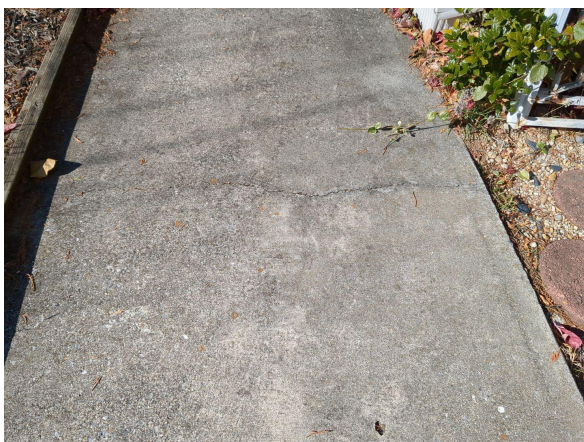
- There are localized cracks in the concrete walk near unit 831. Global Solution Partners recommends repairing the concrete walk using operational funds as part of routine site maintenance.

Localized crack in walk

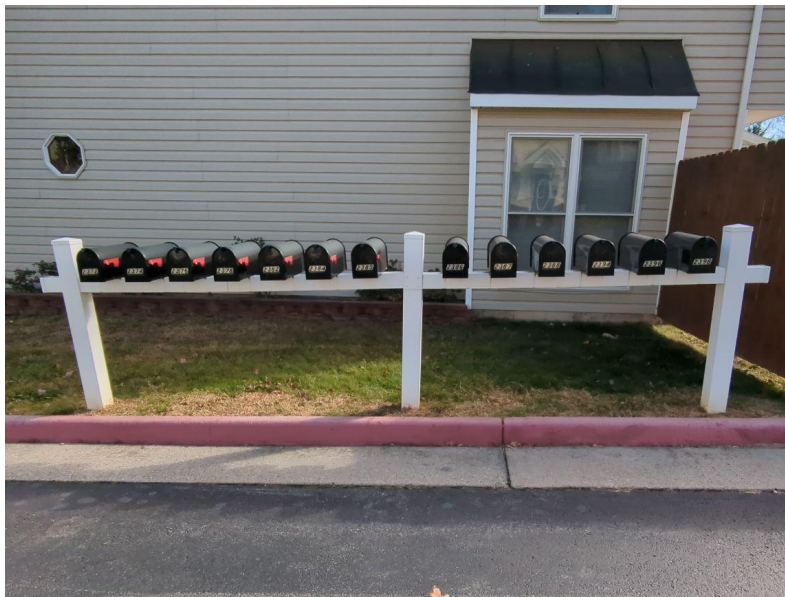
### Site

Item Name	Present Cost	Remaining Life	Expected Life	First Expense Year	First Expense	Repeating Item?
Concrete drainage catch basin replacement for detention pond	\$1,579.20	20 Yrs	40 Yrs	2044	\$2,542.64	Y
Concrete drains and stormwater drainage system repair allowance for parking areas	\$20,266.40	15 Yrs	15 Yrs	2039	\$28,967.57	Y
Gazebo refurbishment	\$12,500.00	0 Yrs	20 Yrs	2024	\$12,500.00	Y
Interlocking block wall replacement for retaining wall	\$53,404.96	20 Yrs	40 Yrs	2044	\$85,986.23	Y
Mailboxes replacement	\$16,976.40	5 Yrs	25 Yrs	2029	\$19,123.06	Y
Street lighting lamps replacement	\$3,680.10	8 Yrs	28 Yrs	2032	\$4,452.44	Y
Vinyl mailbox bank replacement	\$3,000.00	20 Yrs	25 Yrs	2044	\$4,830.24	Y
Wood fencing replacement for dumpster enclosures	\$3,736.12	0 Yrs	16 Yrs	2024	\$3,736.12	Y

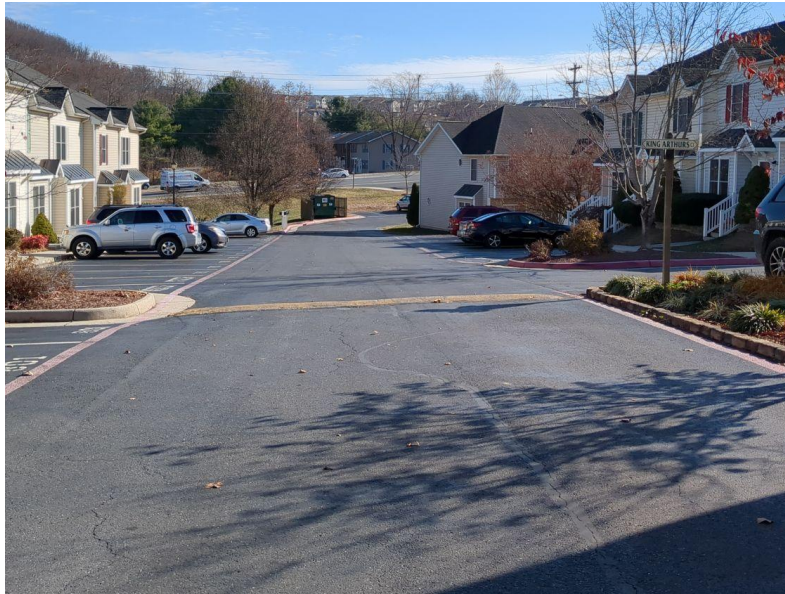
## Paving

Item Name	Present Cost	Remaining Life	Expected Life	First Expense Year	First Expense	Repeating Item?
Asphalt parking areas mill and overlay	\$290,950.04	5 Yrs	25 Yrs	2029	\$327,740.61	Y
Asphalt parking areas patch and seal	\$21,797.56	0 Yrs	5 Yrs	2024	\$21,797.56	Y
Concrete curbing repair allowance (10% every 10 years)	\$8,900.84	10 Yrs	10 Yrs	2034	\$11,294.18	Y
Concrete dumpster pad replacement	\$11,050.56	10 Yrs	20 Yrs	2034	\$14,021.93	Y
Concrete sidewalks repair allowance (10% every 10 years)	\$7,236.58	10 Yrs	10 Yrs	2034	\$9,182.42	Y

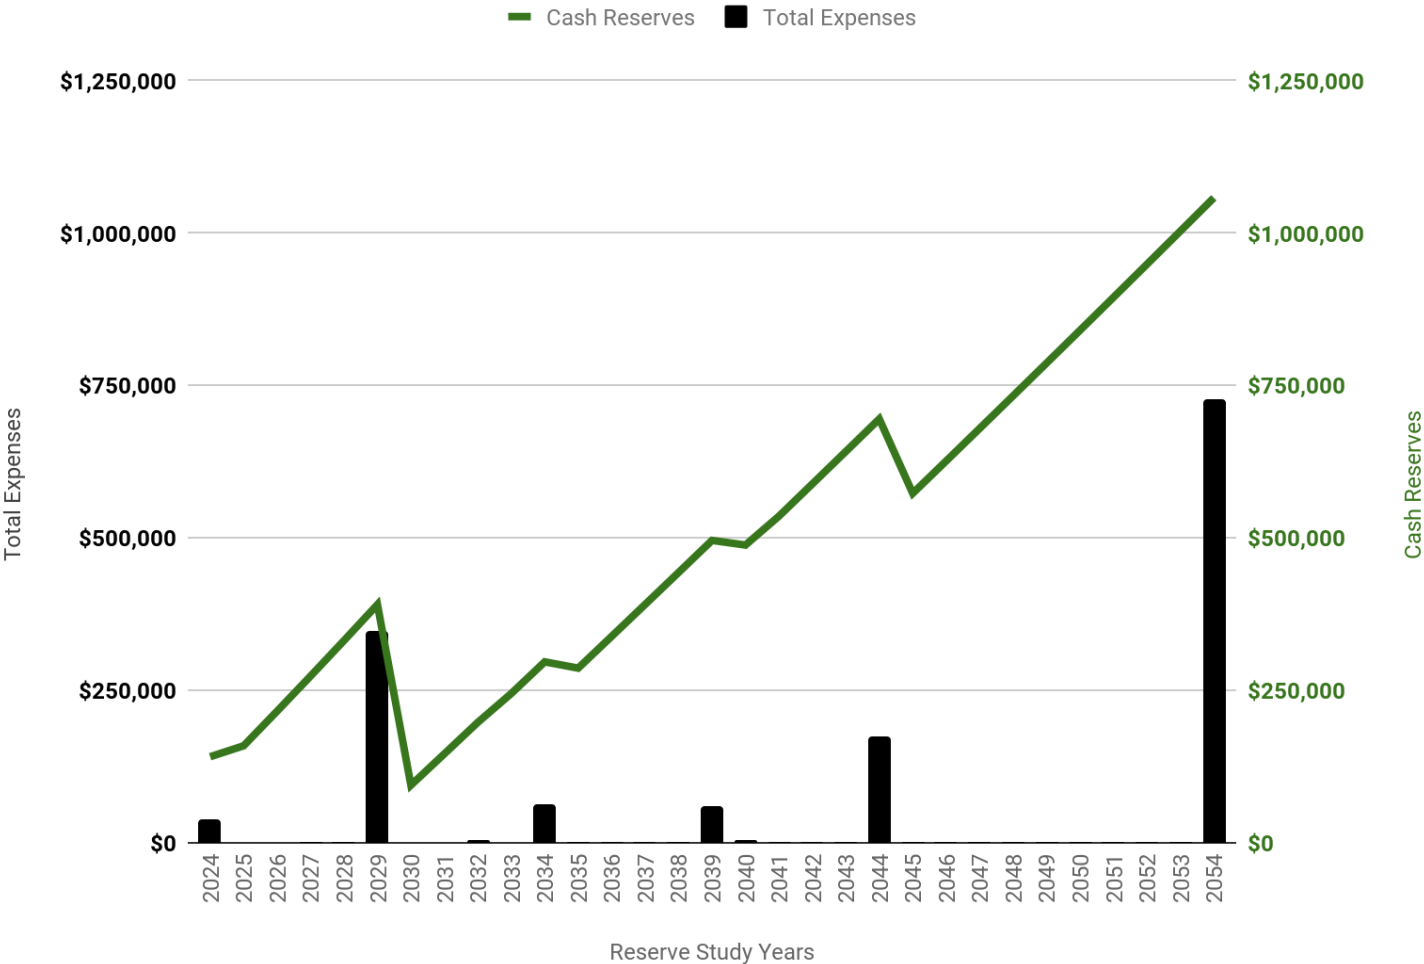
### Cash Flow by Calendar Year

The following chart shows that the reserve account balance meets or exceeds the annual cash flow requirement for the maintenance or replacement of all community reserve items.
